Appendix F1 – Assessment of Controls (Watershed Restoration Assessment)

**WHEEL CREEK
WATER CHEMISTRY MONITORING
YEAR 7 REPORT**

Harford County
Department of Public Works
Watershed Protection and Restoration
212 South Bond Street
Bel Air, Maryland 21014

Thomas S. Jones, Jr.
Daniel Spradlin
Brennan Smith
Versar, Inc.
9200 Rumsey Road, Suite 100
Columbia, Maryland 21045

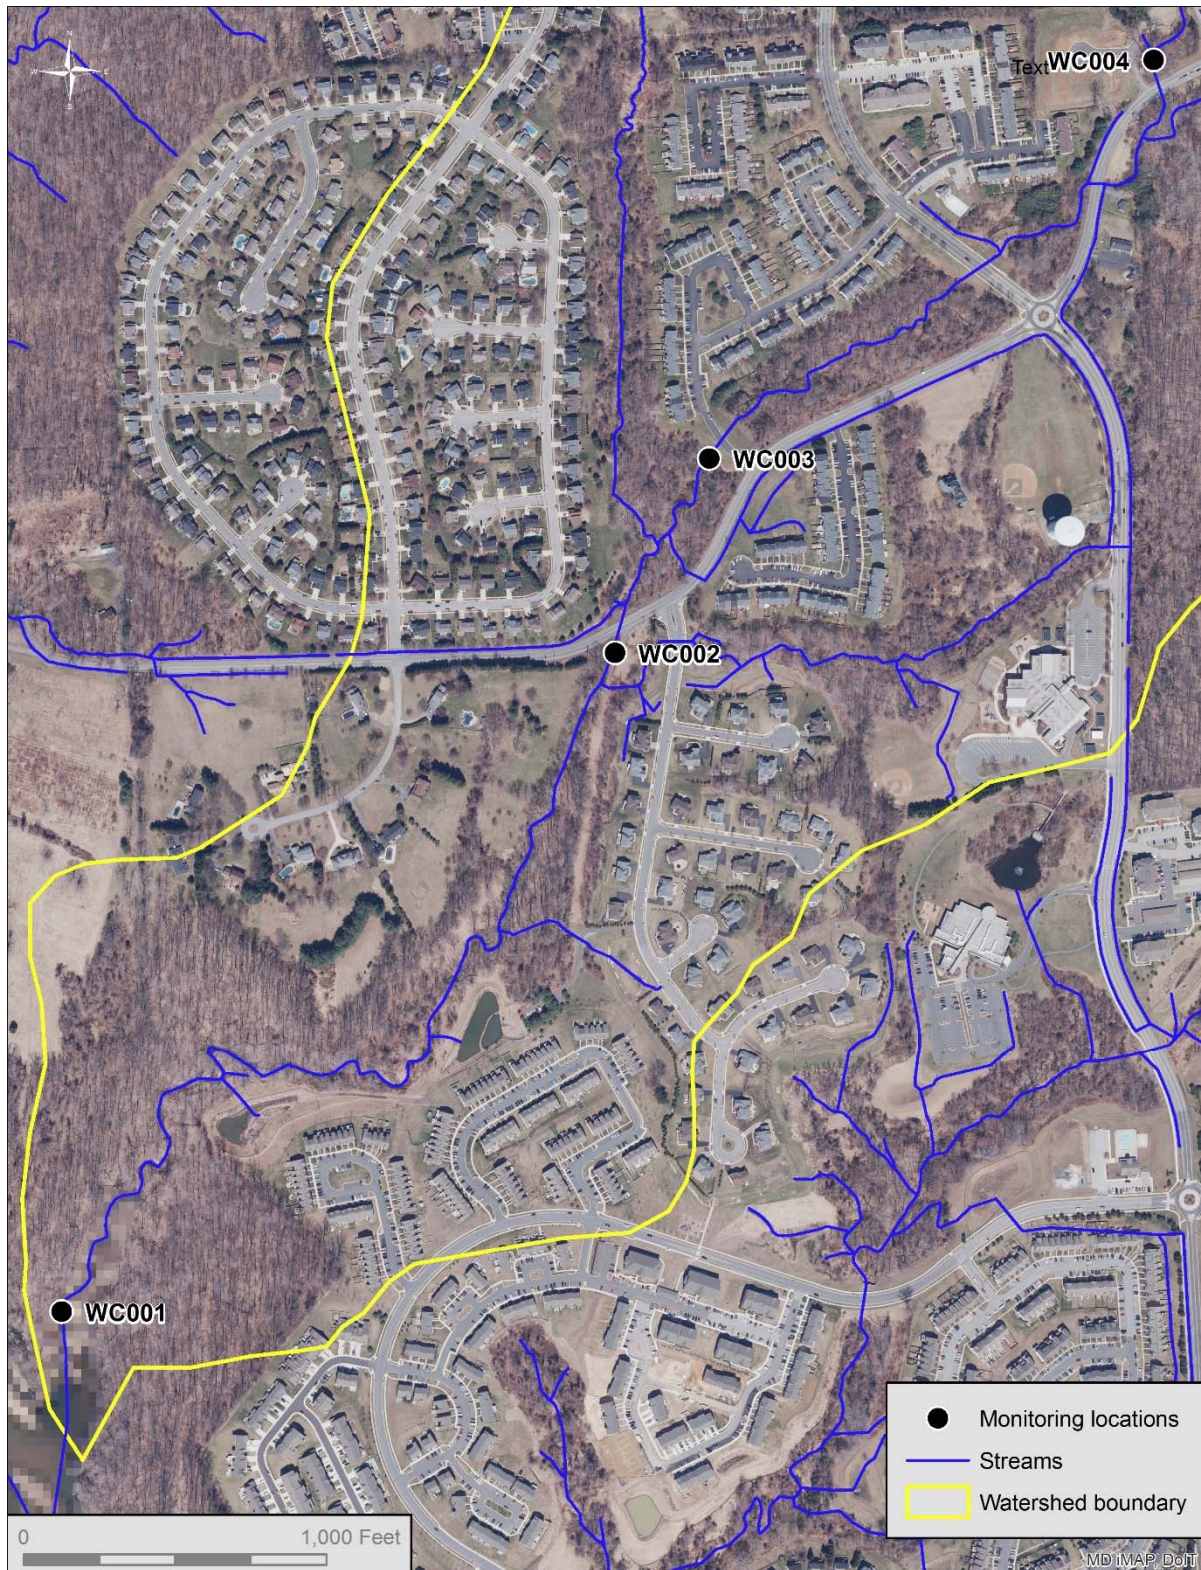
Figure 2-1. Wheel Creek Watershed long-term water chemistry monitoring stations

The water chemistry monitoring study design employs comparisons of pre- and post-restoration and retrofit conditions. Three long-term automated water chemistry sampling and flow logging stations were established at Stations WC002, WC003, and WC004 (Figure 2-1). Station WC004 is located on an unnamed tributary to Wheel Creek immediately downstream of the stormwater retrofit at Festival Shopping Center (Point C). Stations WC003 and WC004 bracket completed stormwater retrofits at Pond D and Pond E along an unnamed tributary. Station WC002 is located on the mainstem and water chemistry data collected there will provide an overall assessment of the benefits of retrofit and restoration projects in upstream tributaries (Figure 2-2). Baseflow monitoring took place at three stations along the Wheel Creek main stem and tributaries (WC002, WC003, and WC004). Nutrient synoptic sampling took place at eight indicator stations in Wheel Creek Watershed (Figure 2-2) and eight control stations in a nearby reference watershed, a tributary to Winters Run (Figure 2-3).

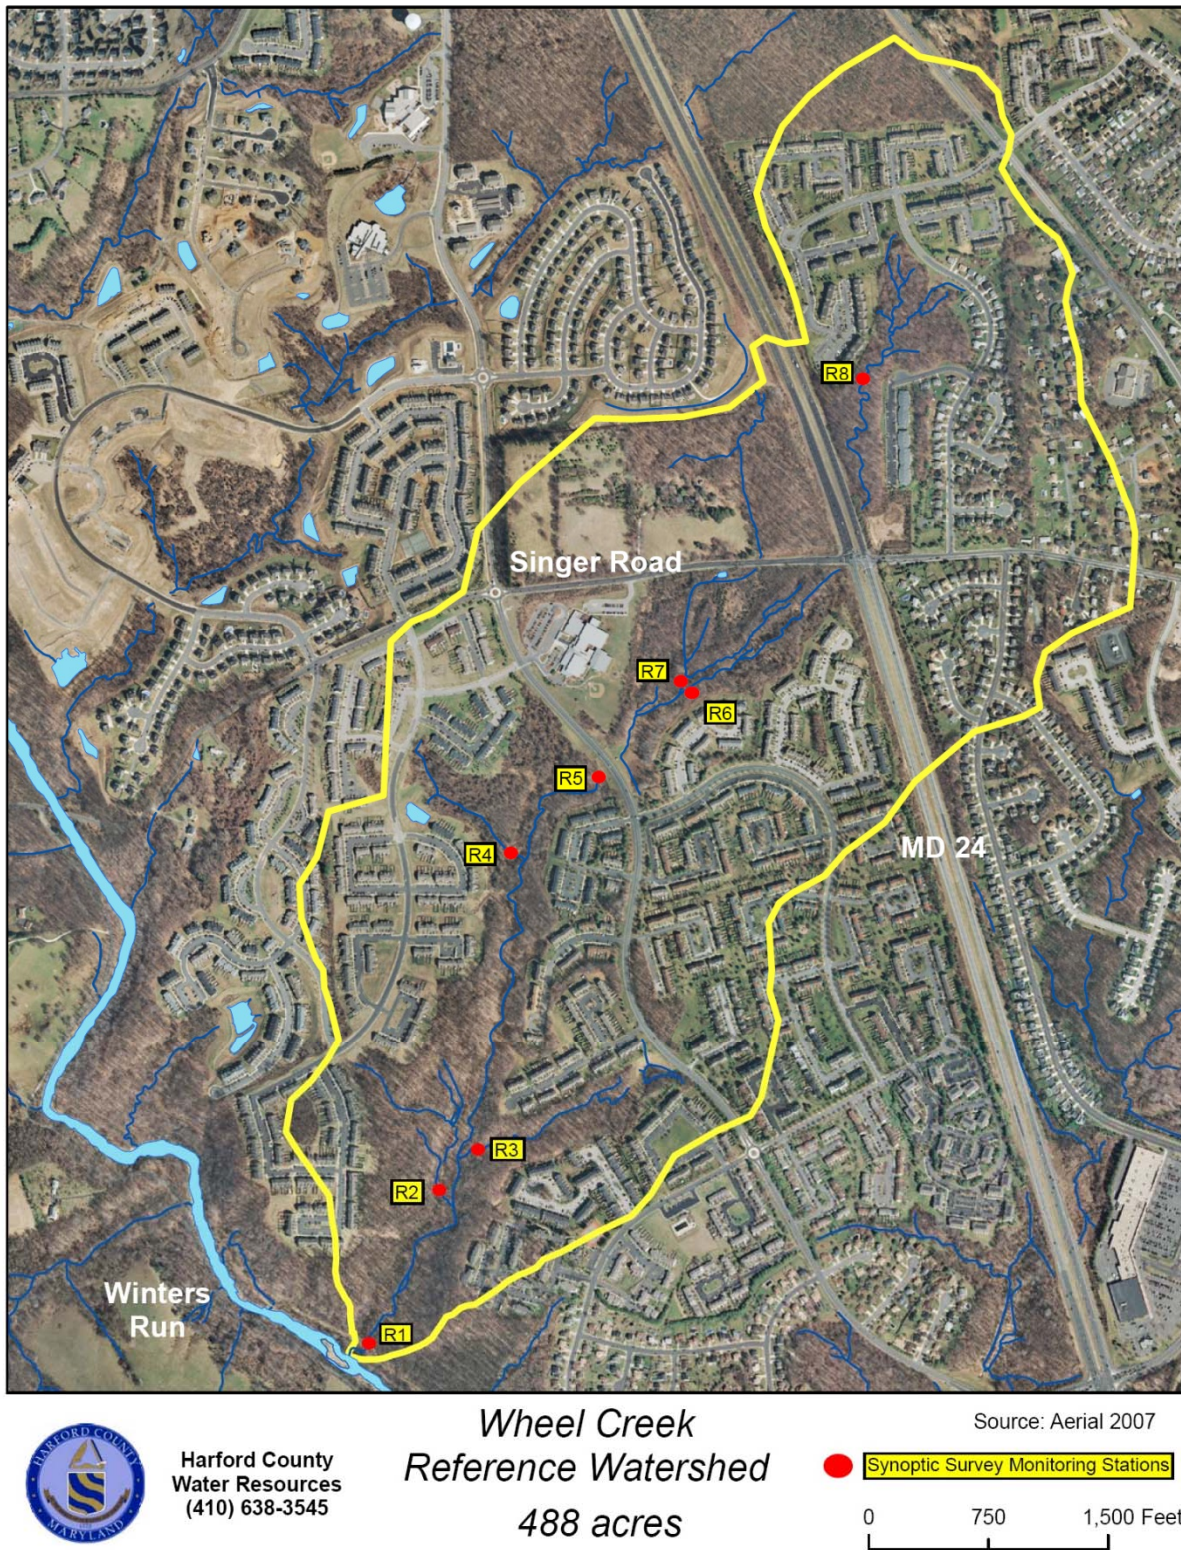
Figure 2-3. Reference synoptic sampling stations
